INSPEKTO
AUTONOMOUS MACHINE VISION

Valve - Outer Rim Integrity Check

Inspection Use Case

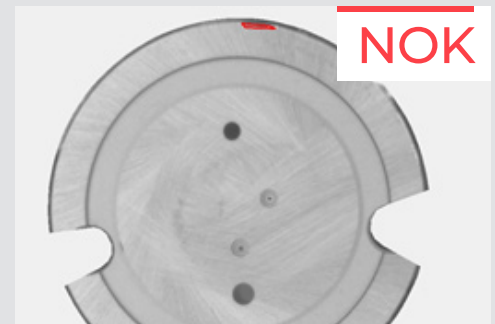
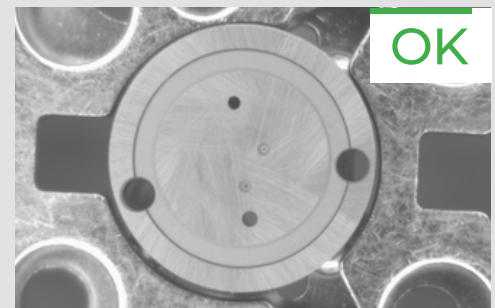
Outer rim integrity check

Metal valve which will be placed in an injector. Outer rim of the valve should be intact and complete, without any breaks.

Dents, damages

- Scratches on the surface of the valve.
- Light reflections on the outer rim and some of the areas.

- Round metal object with rotation freedom.
- Light reflection to be ignored.
