INSPEKTO
AUTONOMOUS MACHINE VISION

Valves Pallet - Presence / Absence / Positioning

Inspection Use Case

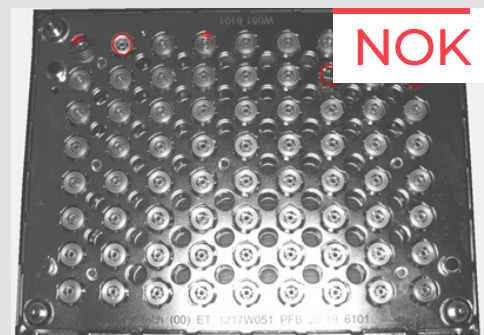
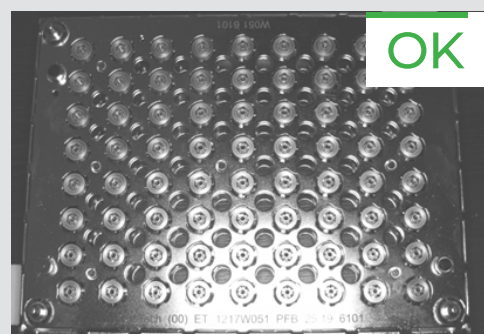
Ensure the existence and correct positioning of sub-components (injector valves) before robotic pickup for automatic assembly in the injector body.

- Absence of sub-component / missing part
- Wrong positioning - orientation, location

72 sub-components in 1 shot, each of them can have a different defect type.
