INSPEKTO
AUTONOMOUS MACHINE VISION

Piston Side - Integrity Check

Inspection Use Case

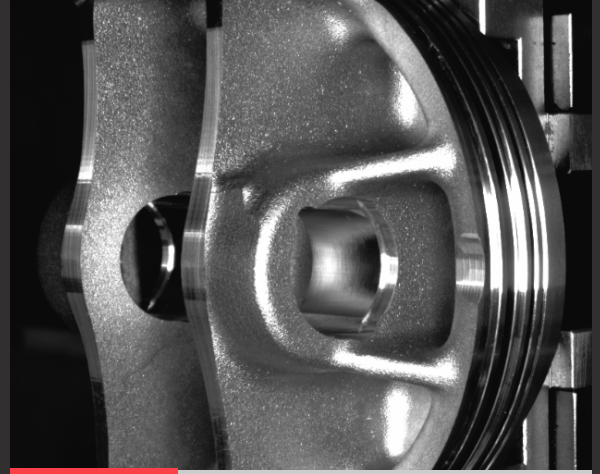
Pistons are used in every combustion engine. Here the S70 inspects for the integrity of the piston's bump and for scratches in the side of the piston's pocket.

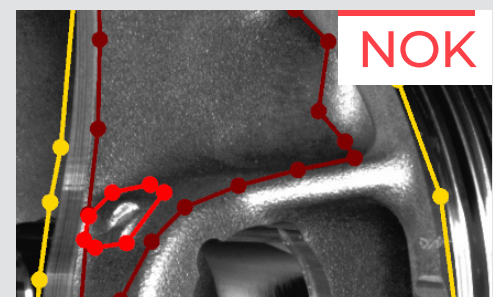
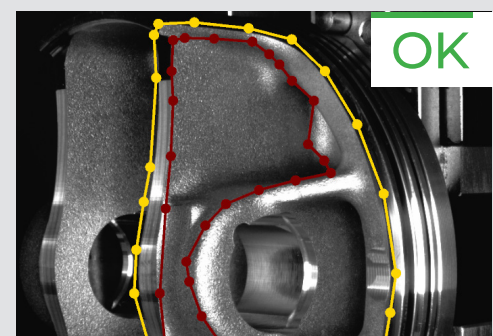
Using INSPEKTO S70

Check bump and pocket of a piston
